Subject: RE: Gold King Mine Spill - brief background and initial EPA Region 9 response (internal - do

Subject: Gold King Mine Spill - brief background and initial EPA Region 9 response (internal -

When our river turned orange

Nine things you need to know about the Animas River mine waste spill.

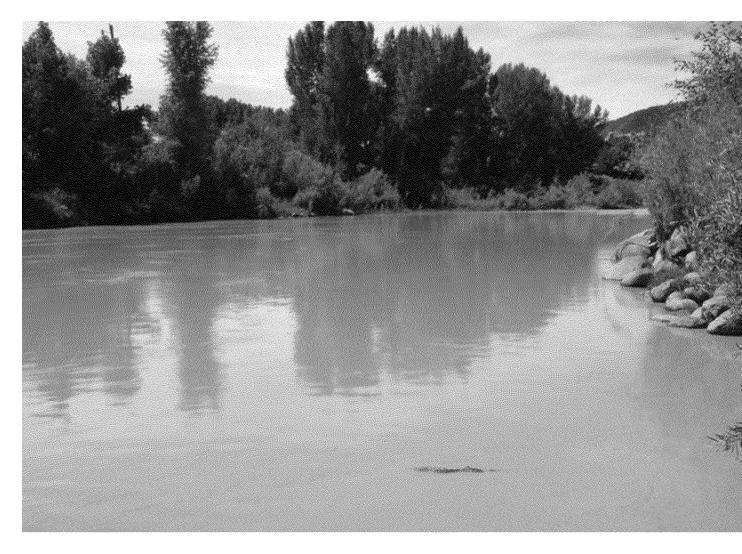
The river turned a mustardy-Tang color as the wastewater moved through. This was taken about 24 hours after the spill.

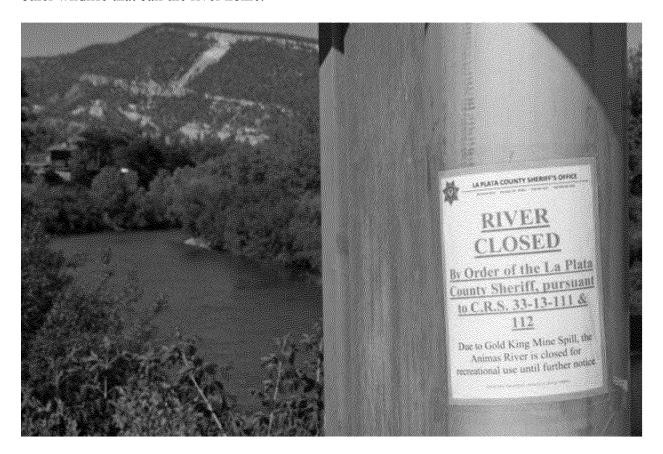
The Animas River was closed for public safety as the wastewater plume moved through town.

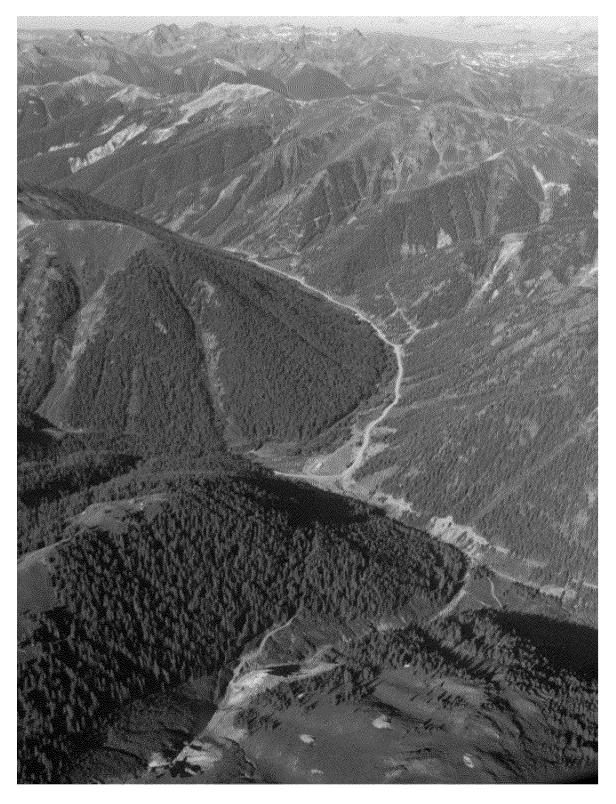
The Gold King Mine (bottom of picture) and Cement Creek. Cement Creek has probably never supported fish, and even before the spill had a pH level of about 3.5, on par with Coca-Cola.
